Comprehensive Asbestos-Containing Materials Inspection

233 West Dominick Street
Rome, New York 13440

2223781

September 22, 2022

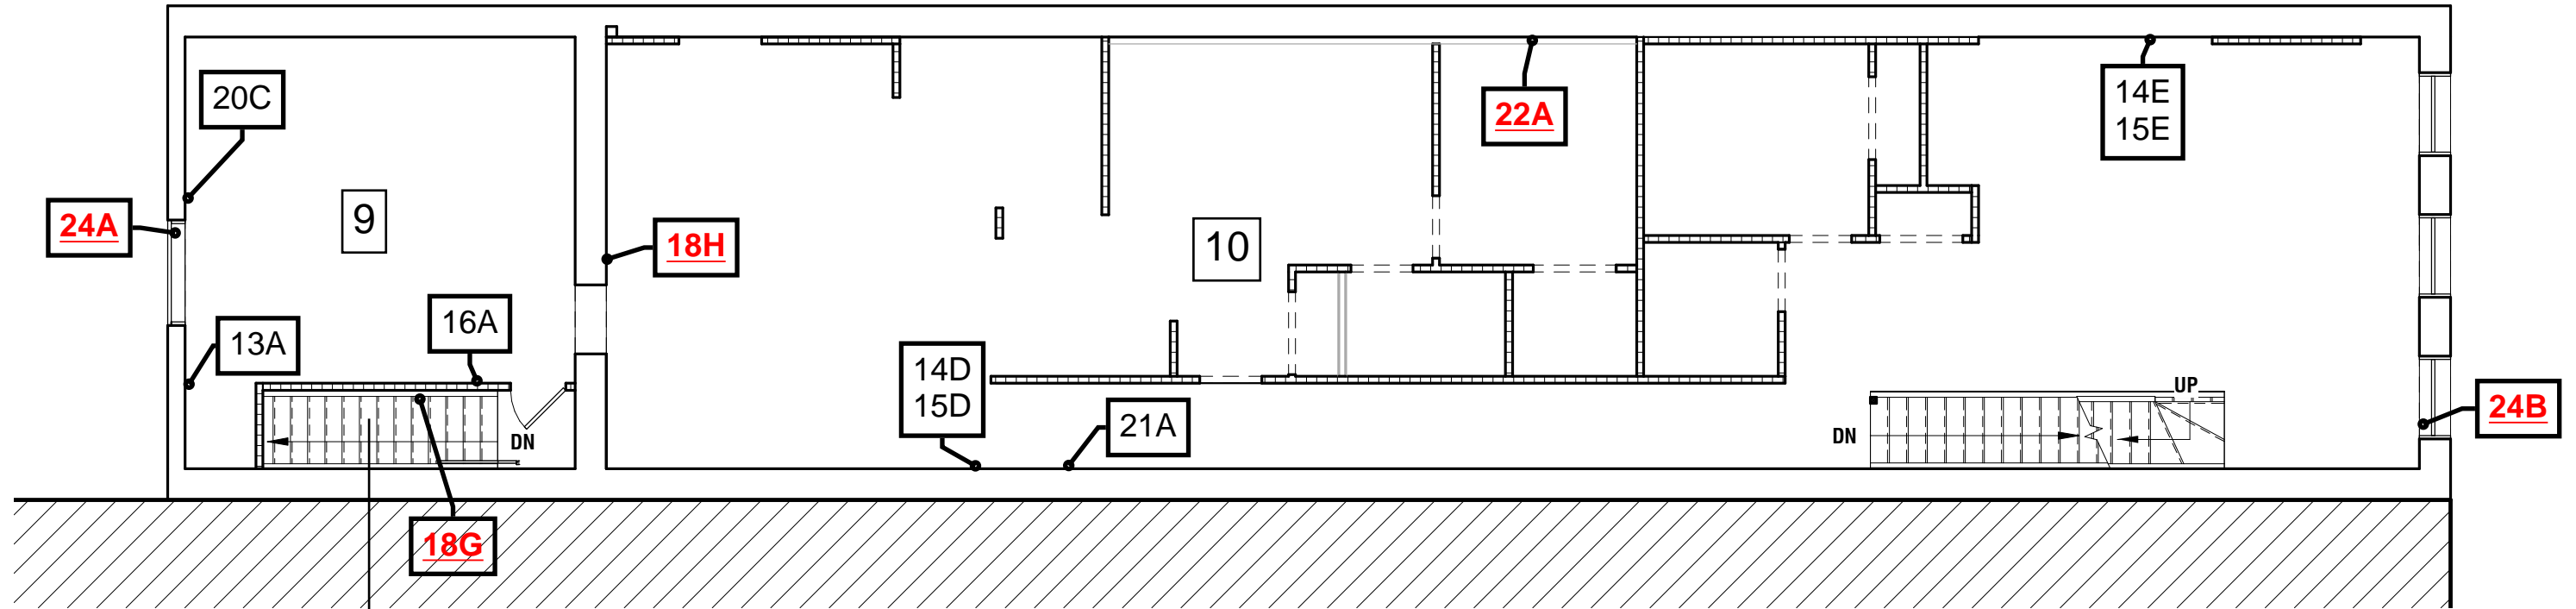
1 2ND FLOOR PLAN
A103 1/8" = 1'-0"

Confirmed ACM **24A, 18H, 22A, 14E, 15E, 18G, 21A, 14D, 15D, 24B**

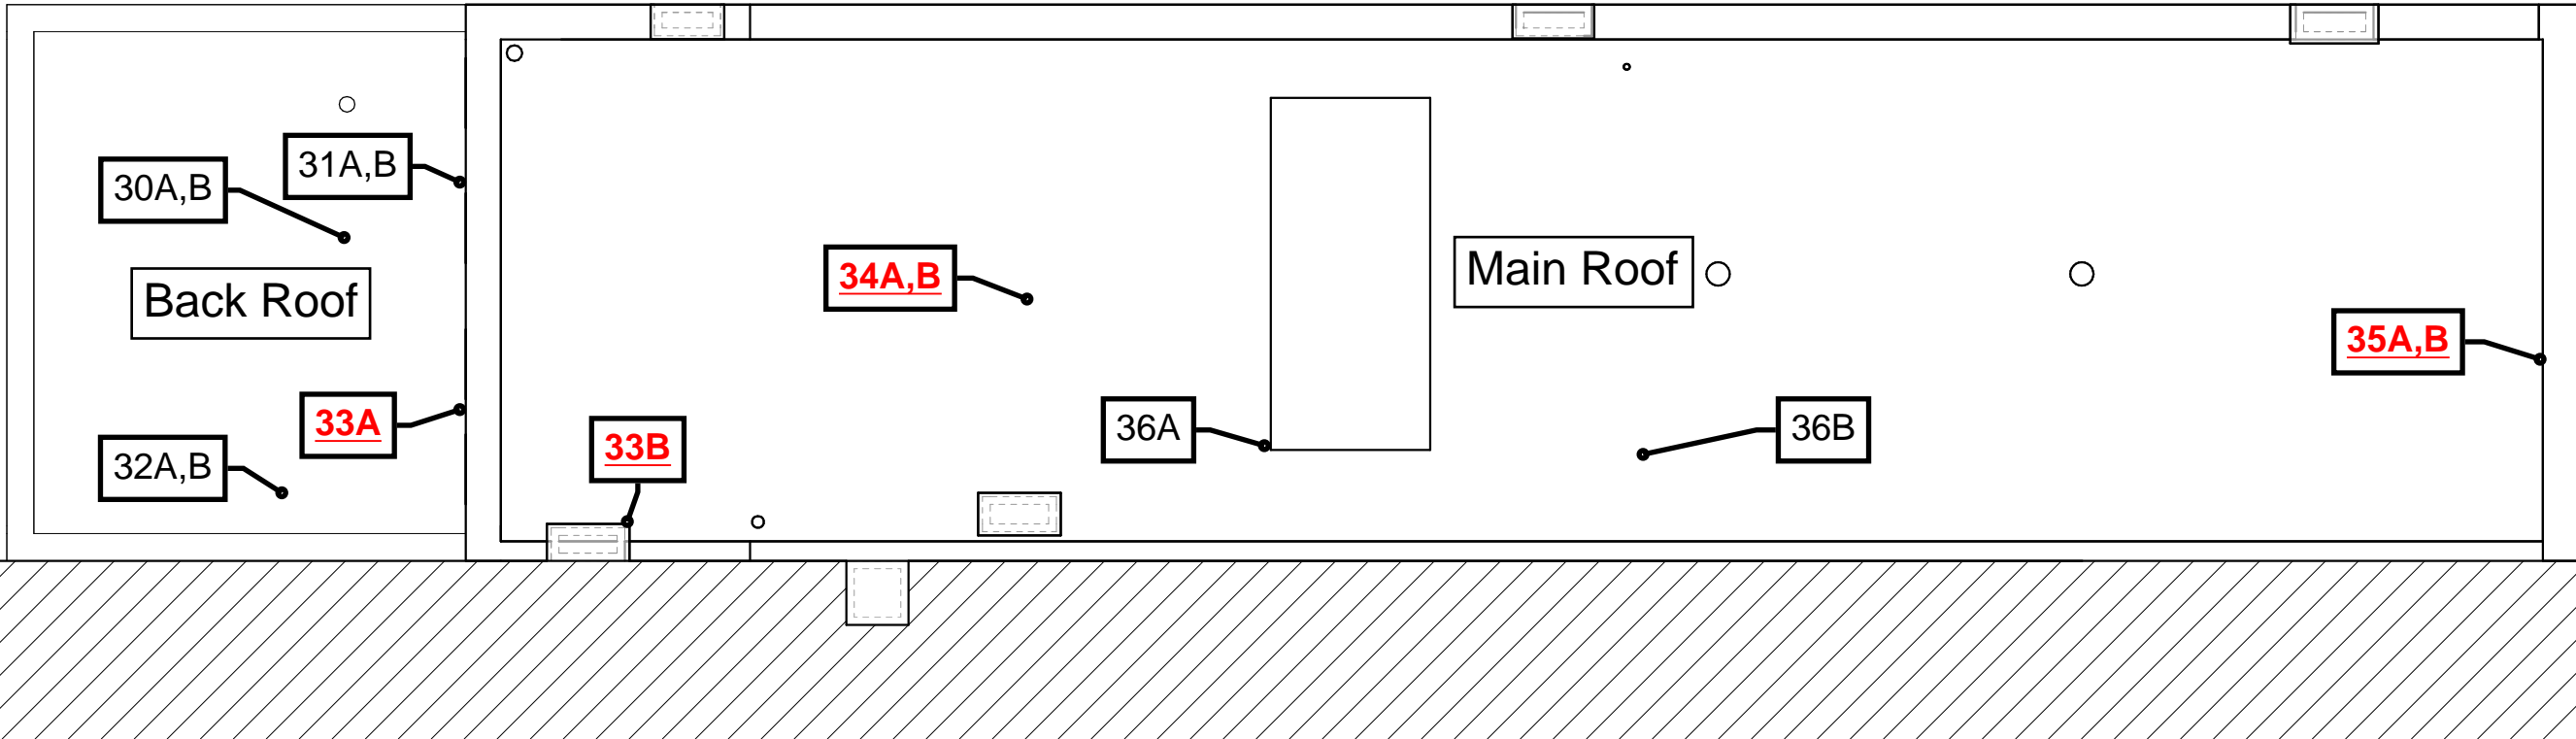
1 ROOF PLAN
A105 1/8" = 1'-0"

Confirmed ACM **34A,B**

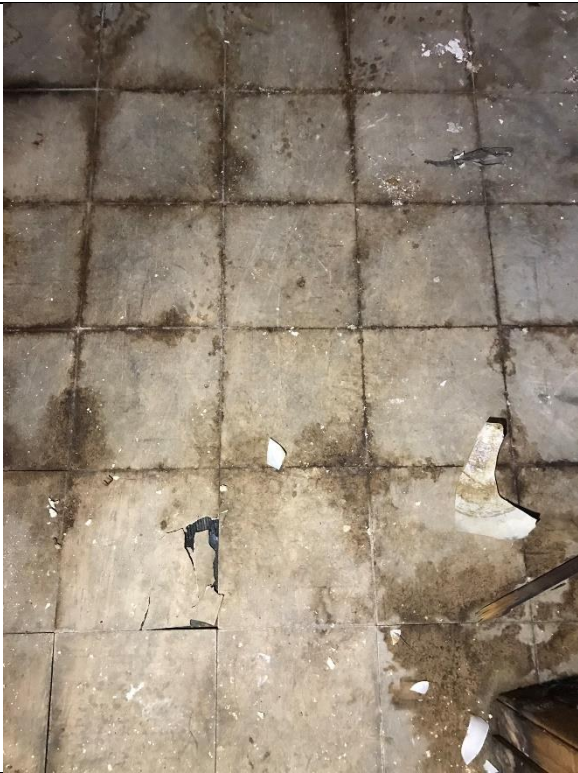
Photo 1

- Room 2 (predominantly mastic only)
- Basement stairwell landing (mastic only)
- 1st floor stairwell landing (mastic only)
- Room 6 (mastic only)
- Room 7

View of Brown Asbestos-Containing 9" Floor Tile and Associated Black Floor Tile Mastic in Room 7

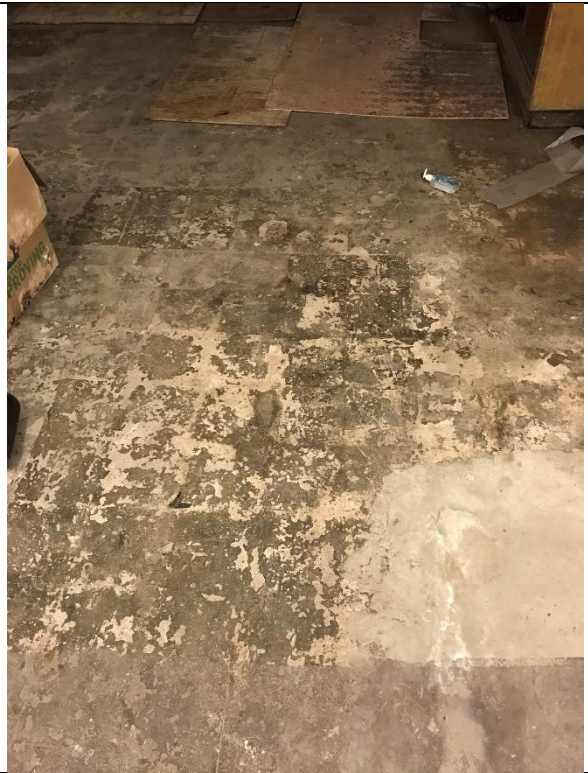
Photo 2

View of Black Asbestos-Containing Floor Tile Mastic in Room 2

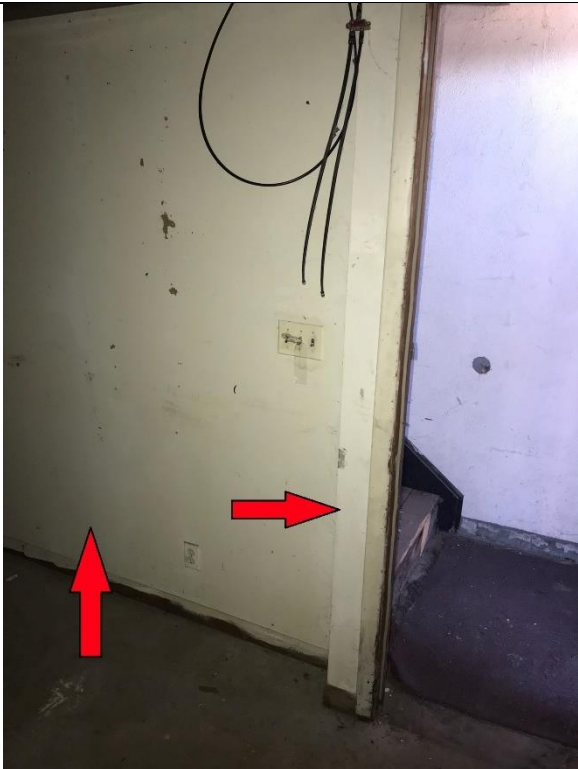
Photo 3

View of White Asbestos-Containing Joint Compound in Room 1

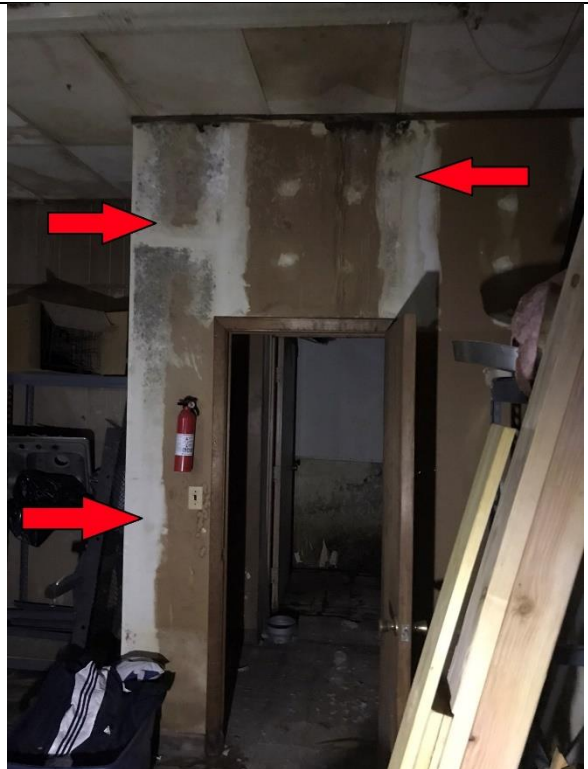
Photo 4

View of White Asbestos-Containing Joint Compound in Room 7

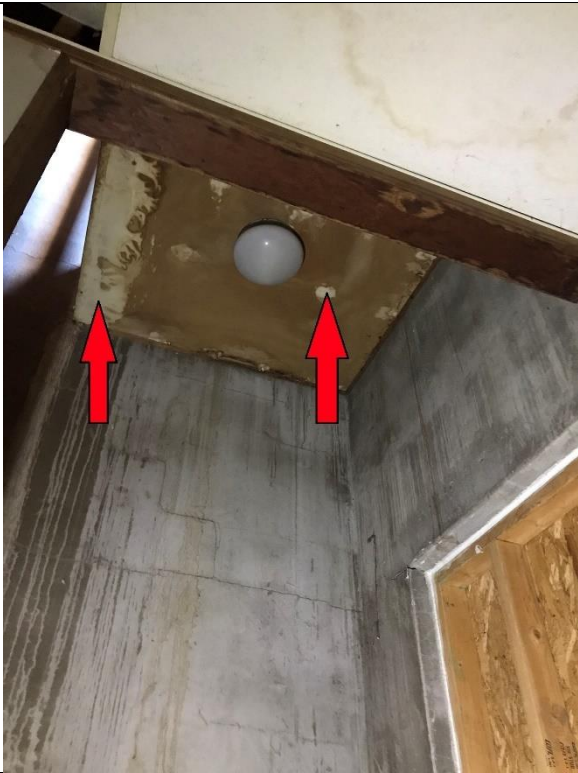
Photo 5

- White Joint Compound
 - On Wood Studs in Room 9 – approximately 125 square feet
 - On Wood Studs & Walls in the 2nd Floor Stairwell – approximately 75 square feet
- Gray Debris (Window Glazing Compound)
 - On the South Side of the Building Ground – approximately 530 square feet (23’ x23’)

View of White Asbestos-Containing Joint Compound in the 2nd Floor Stairwell

As stated earlier, the presence of damaged asbestos-containing materials were noted in several locations throughout the subject building. These conditions represent “Incidental Asbestos Disturbances” as defined by New York State Asbestos Regulations, (i.e., Industrial Code Rule 56). According to these regulations, personnel access to the areas affected shall be restricted until such time as the materials are cleaned up by a licensed asbestos abatement contractor. The clean-up of these materials shall take place as soon as possible.

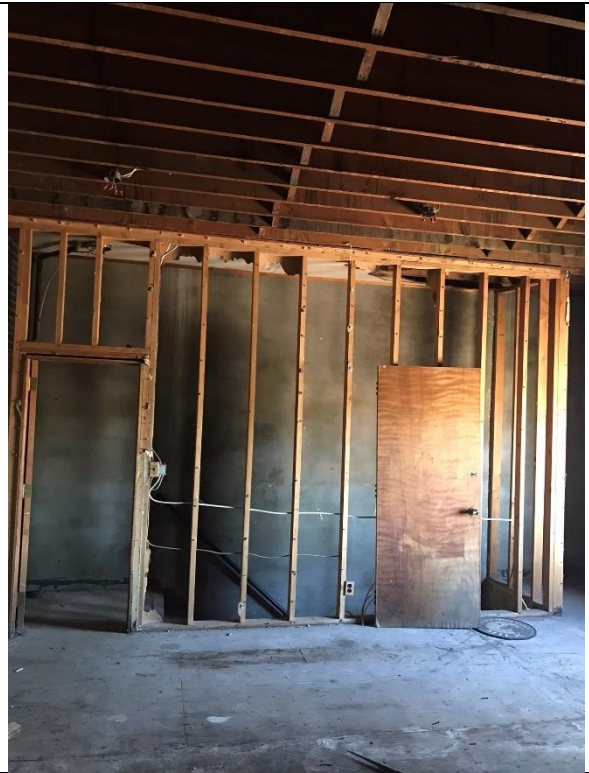
Photo 6

While most areas of joint compound were in good condition, several areas of drywall were previously removed disturbing the underlying joint compound in the process.

View of White Asbestos-Containing Joint Compound remnants in Room 9

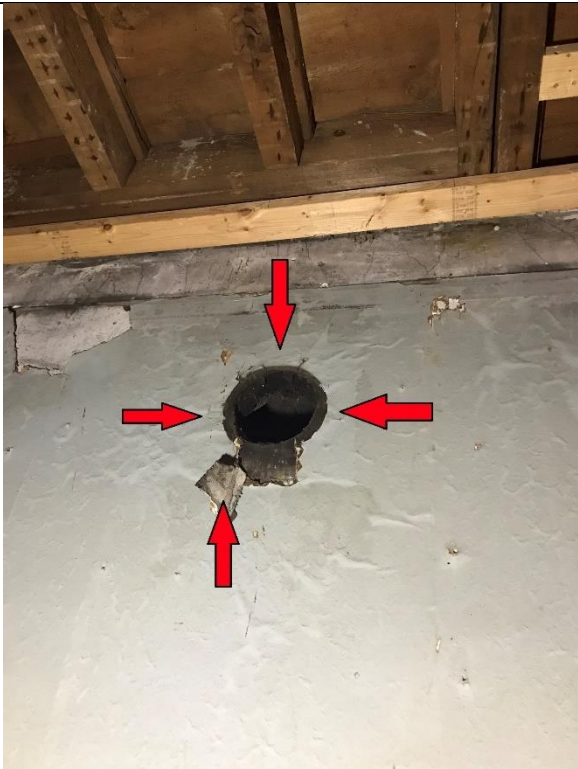
Photo 7

View of Gray Asbestos-Containing Insulation on the West Wall in Room 10

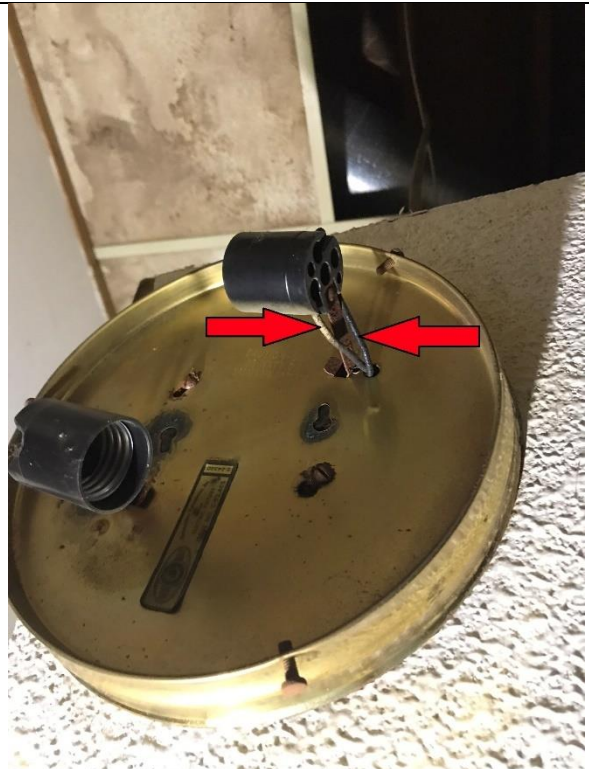
Photo 8

Black and white asbestos-containing wire insulation is located inside the small circular light fixtures in the following locations:

View of Black and White Asbestos-Containing Wire Insulation in the Light Fixture in Room 6

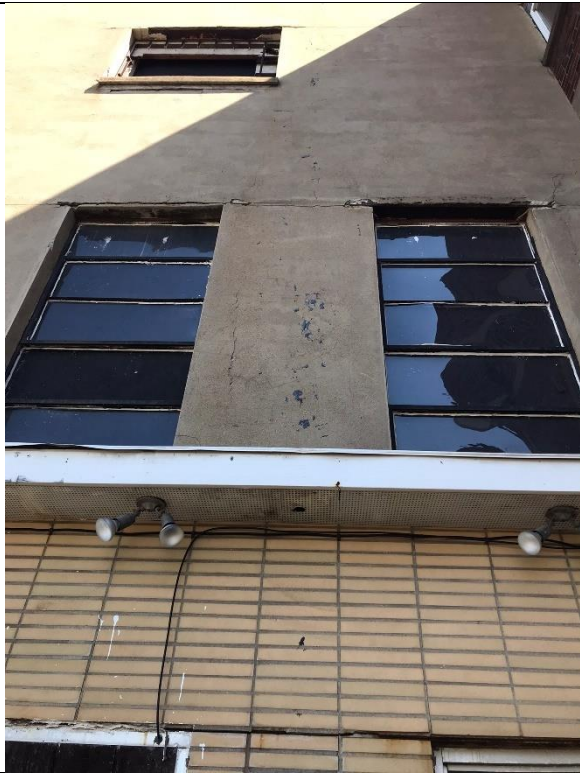
Photo 9

View of Gray Asbestos-Containing Window Glazing Around Glass Panes of Metal Exterior Windows

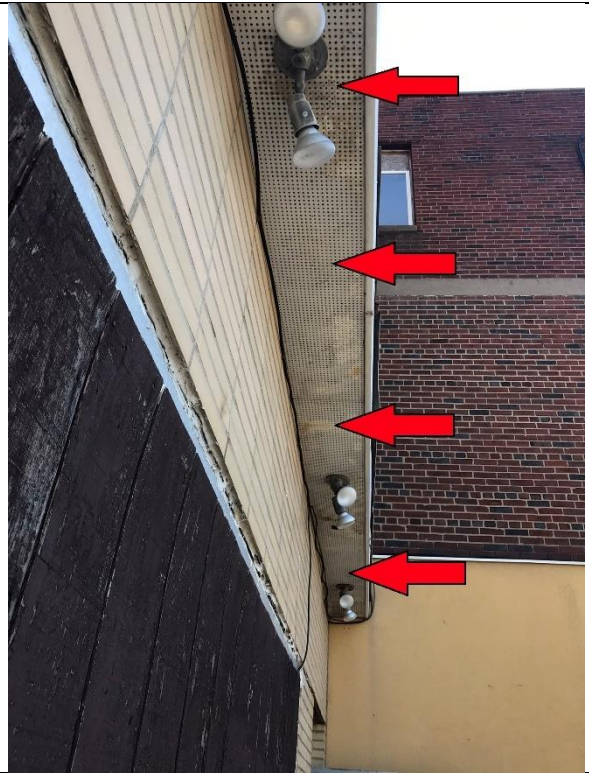
Photo 10

View of Gray Asbestos-Containing Transite Soffit Panels on the South Side of the Building

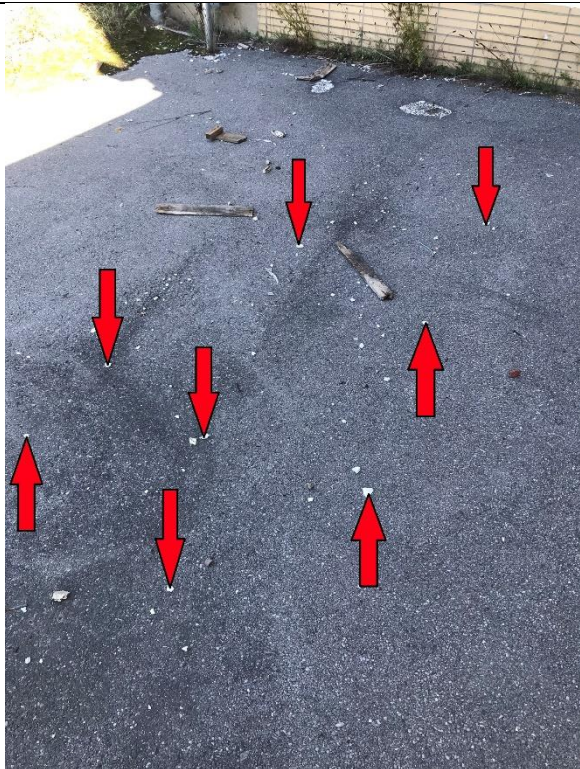
Photo 11

Scattered gray asbestos-containing debris was observed on the ground along the south side of the building (exterior).

View of Gray Asbestos-Containing Debris on the Ground on the South Side of the Building

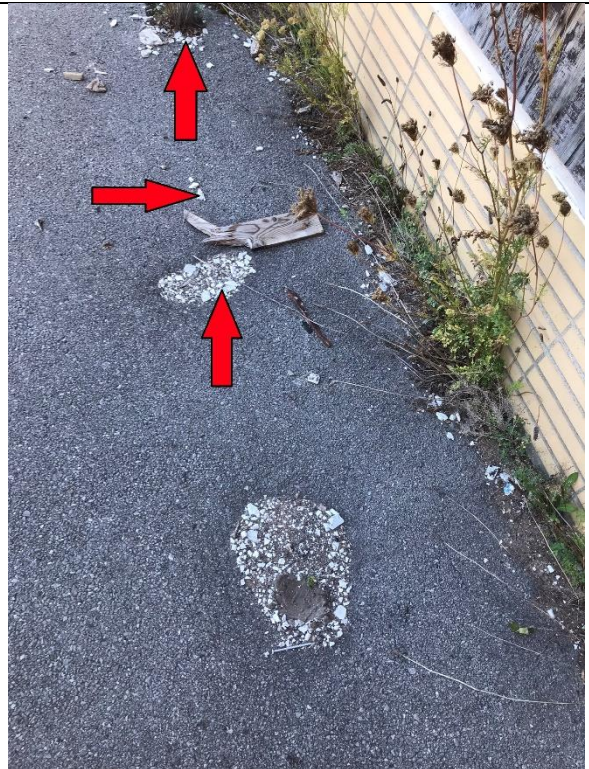
Photo 12

View of Gray Asbestos-Containing Debris on the Ground on the South Side of the Building

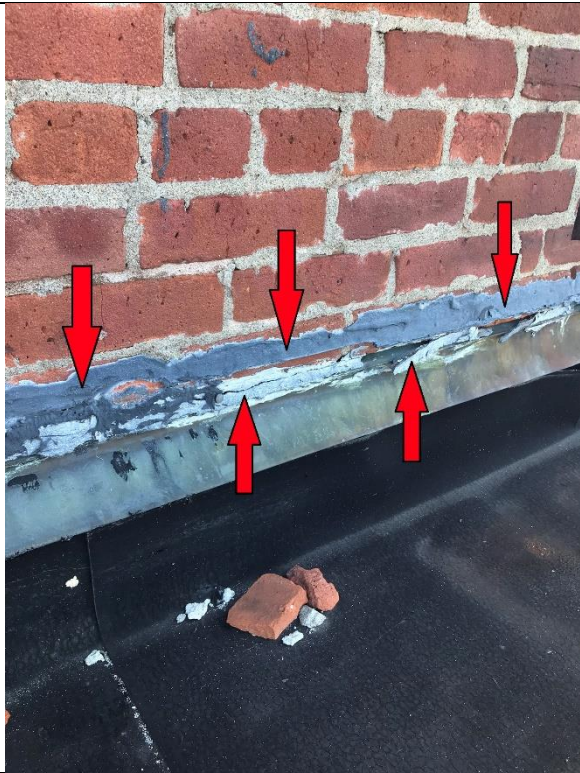
Photo 13

View of Black Asbestos-Containing Roofing Cement Along Top of Flashing on the Back Roof

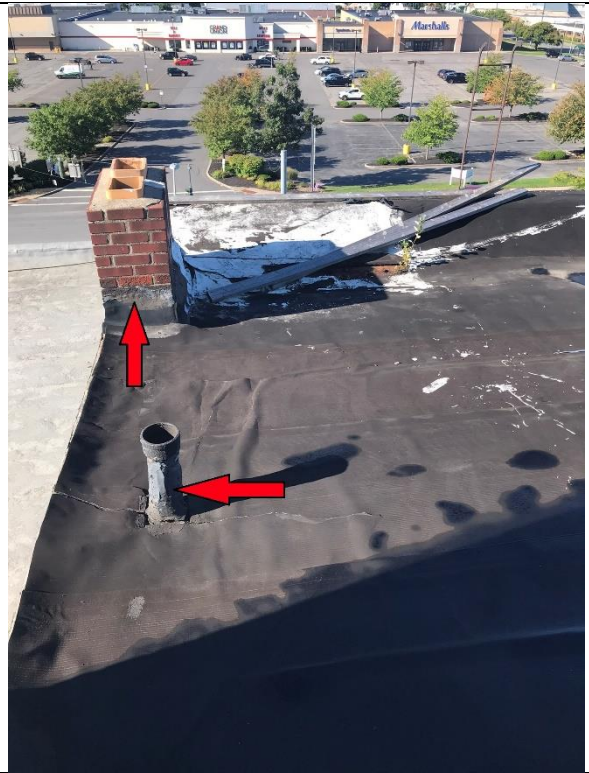
Photo 14

View of Black Asbestos-Containing Roofing Cement Around Chimney and Pipe on Main Roof

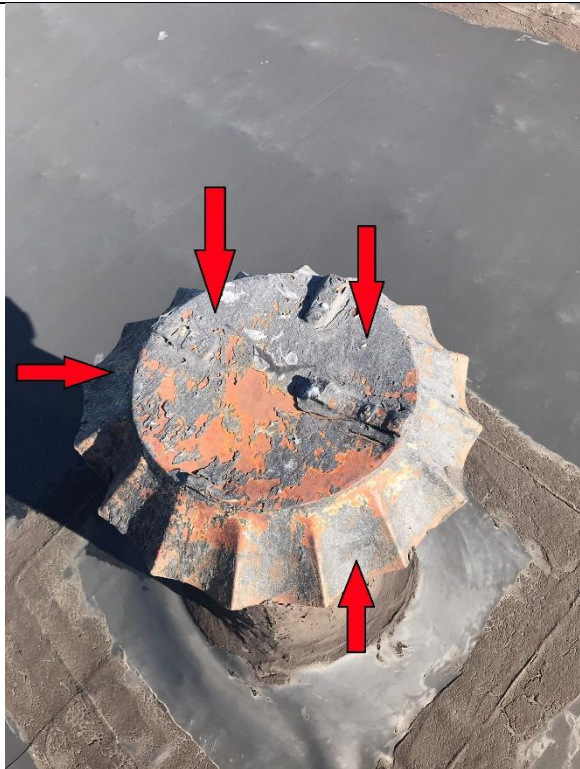
Photo 15

View of Black Asbestos-Containing Roofing Cement Around Exhaust Fans on the Main Roof

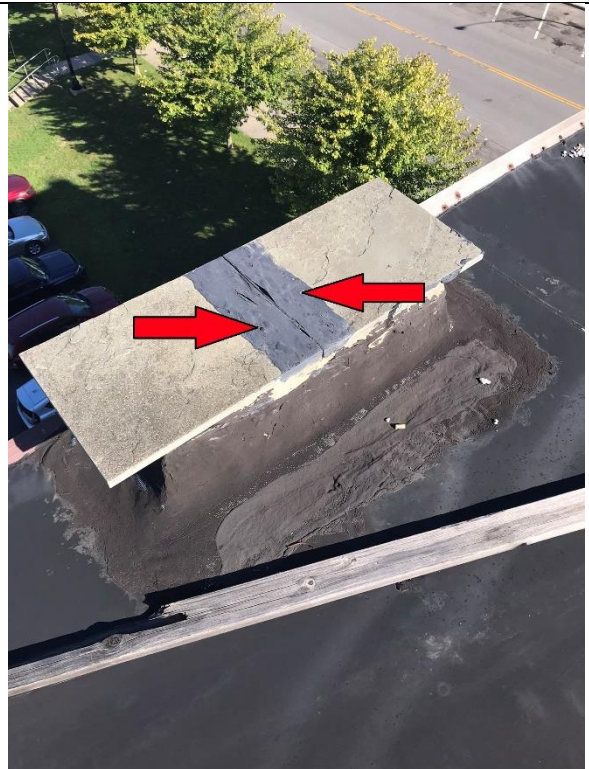
Photo 16

View of Black Asbestos-Containing Roofing Cement Along Stone Cap on Main Roof

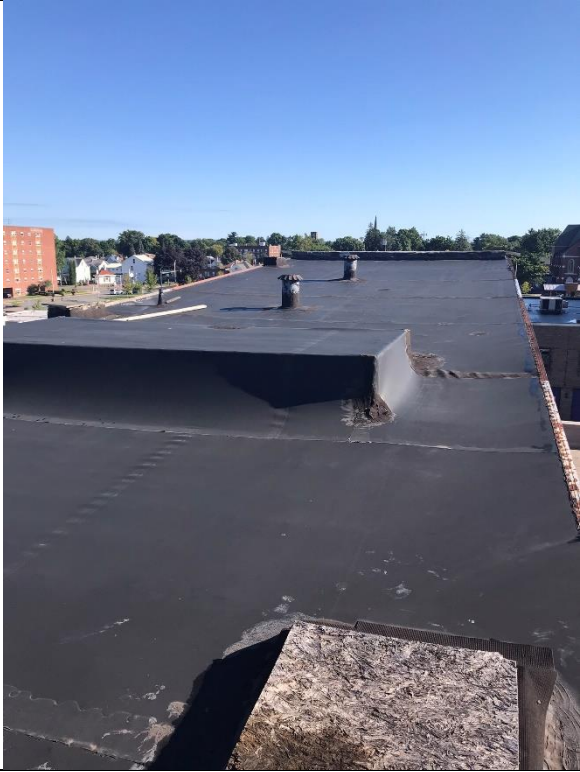
Photo 17

View of Black Asbestos-Containing Roofing on the Main Roof (2nd Layer Under EPDM Rubber)
