Comprehensive Asbestos-Containing Materials Inspection

233 West Dominick Street
Rome, New York 13440

2223781

September 22, 2022

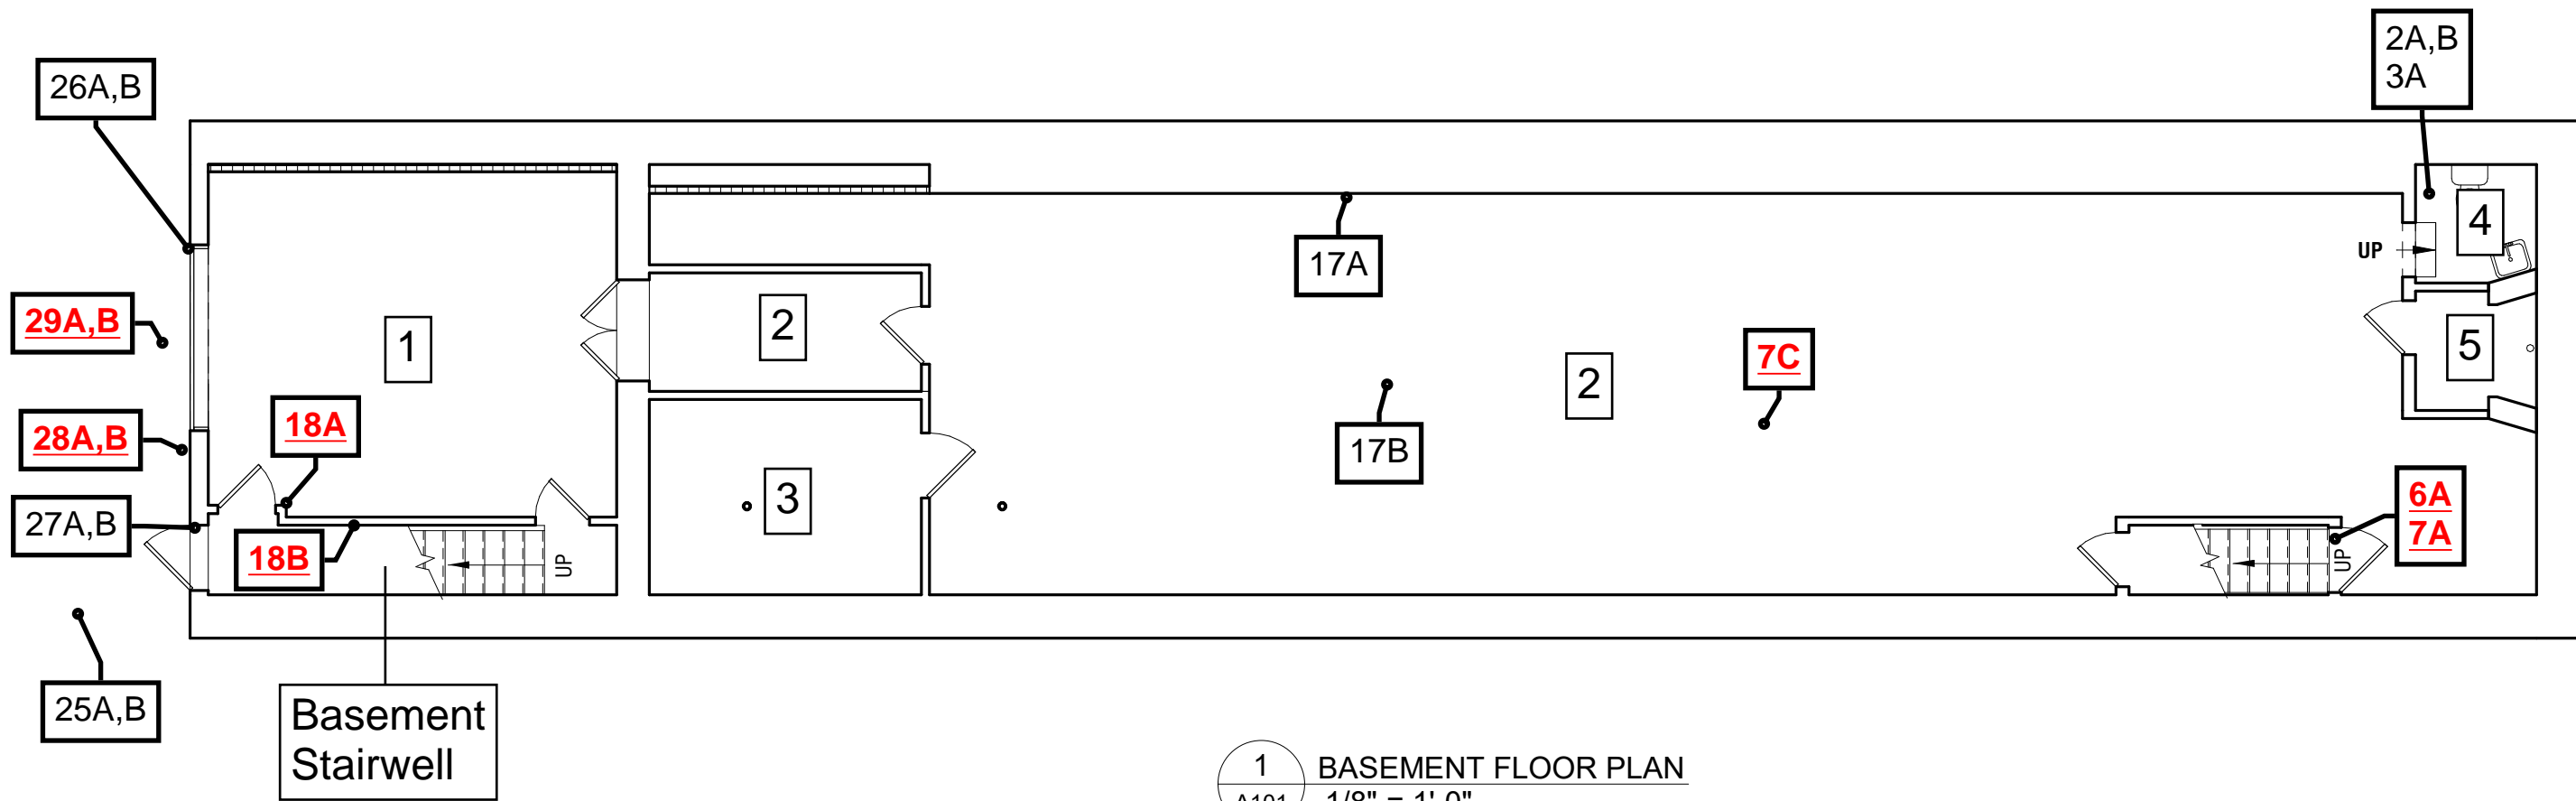
1 BASEMENT FLOOR PLAN
 A101 1/8" = 1'-0"

Project Number: 2223781
 233 West Dominick Street
 Basement/Exterior Bulk Samples

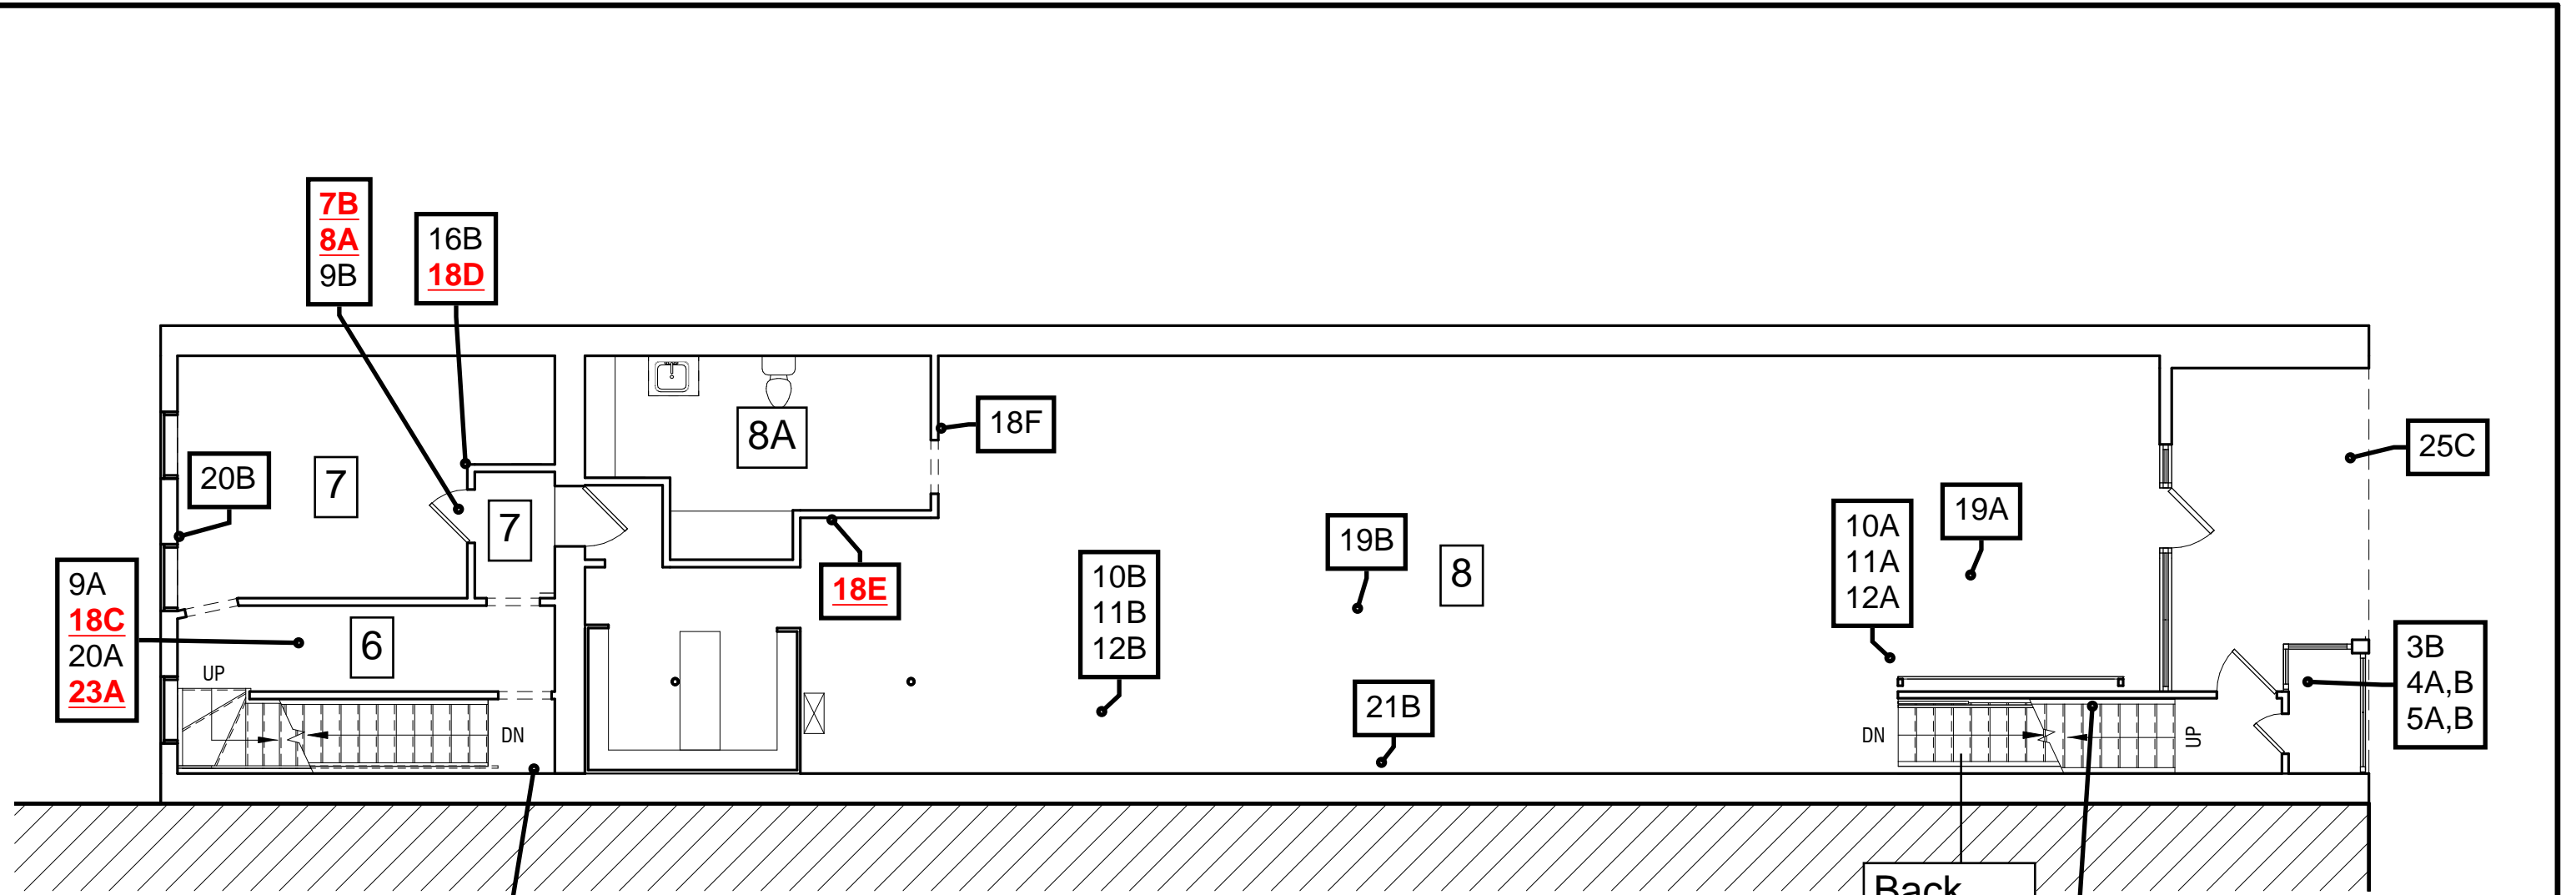
1 FIRST FLOOR PLAN
A102 1/8" = 1'-0"

Project Number: 2223781
233 West Dominick Street
First Floor/Exterior Bulk Samples

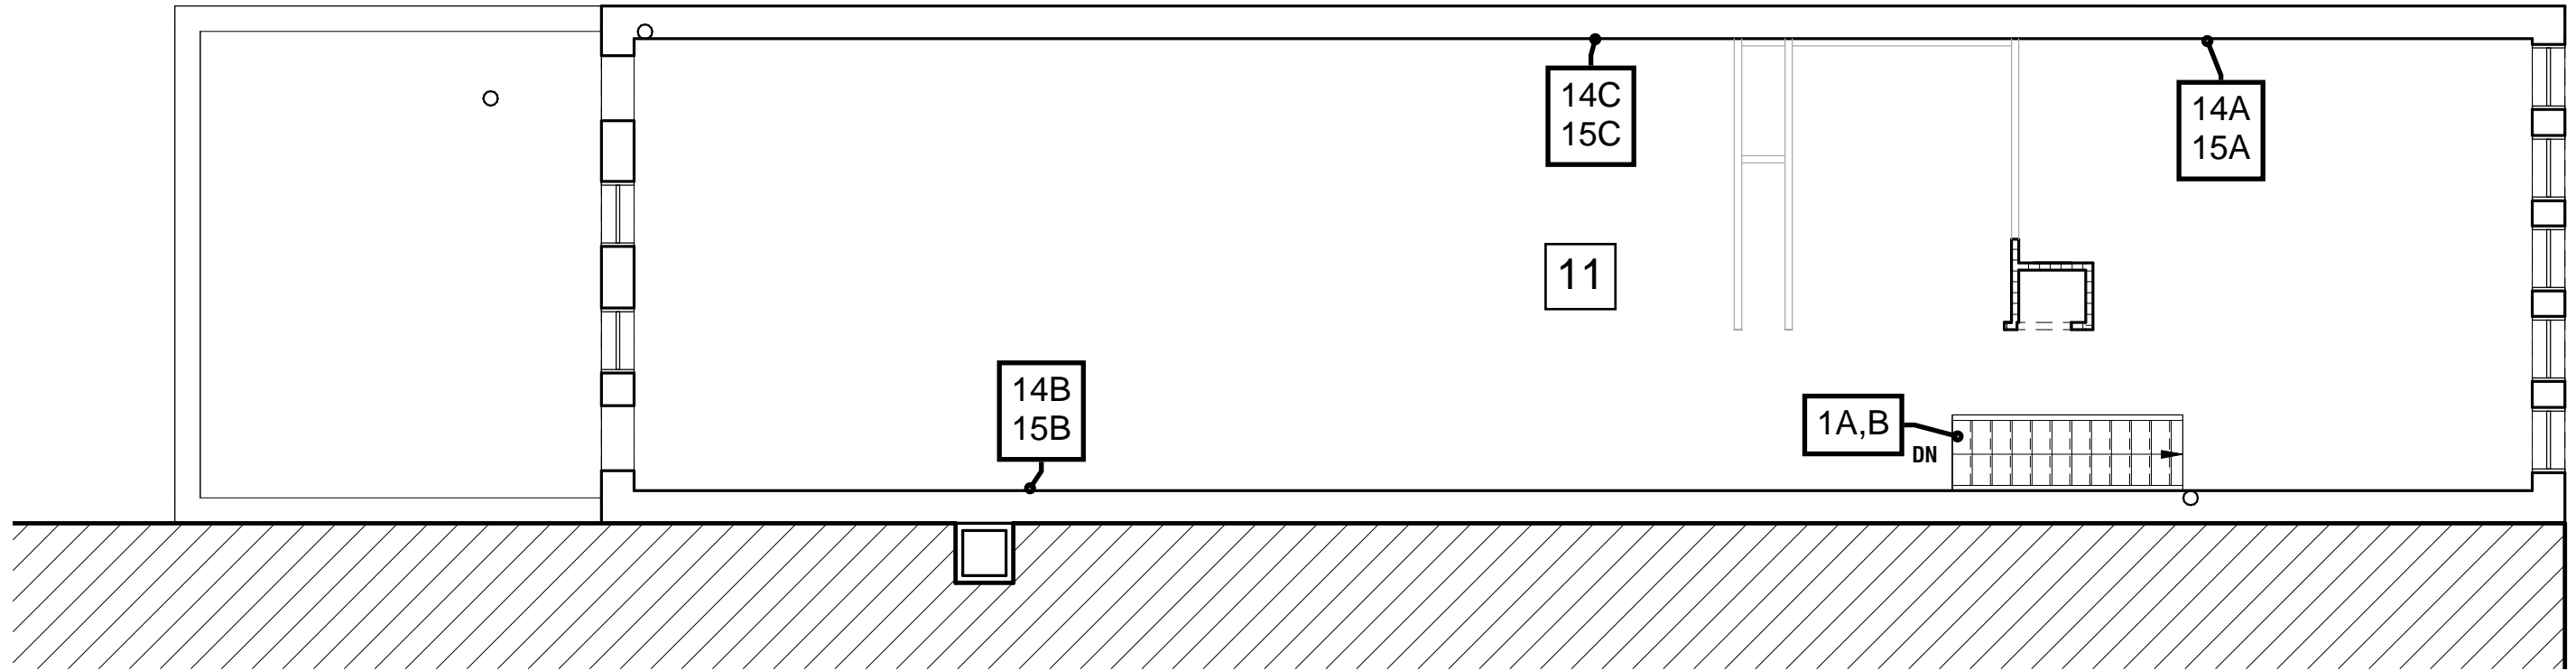
1 3RD FLOOR PLAN
A104 1/8" = 1'-0"

Project Number: 2223781
233 West Dominick Street
Third Floor Bulk Samples
